Russell Inspection Services LLC

Property Condition Assessment

123 Main ST
Anytown NH 01234

Date: 1/1/2018	Time: 08:30 AM	Report ID: 12345
Property: 123 Main ST Anytown NH 01234	Customer: Sample Report

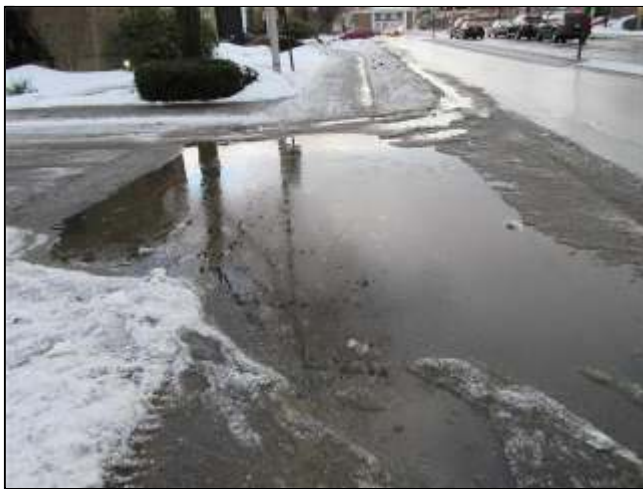
1.1 Storm water run-off is disposed of through the municipal drains at the street and at the rear parking lot. There was some ponding of water located at the front entrance, however this appears to be caused by a municipal drain blocked with snow.

1.1 Item 1(Picture) Ponding/front entrance.

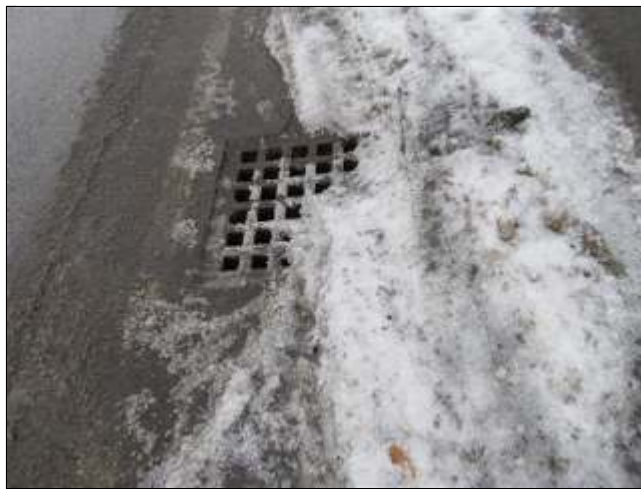
1.1 Item 2(Picture) Drain blocked.

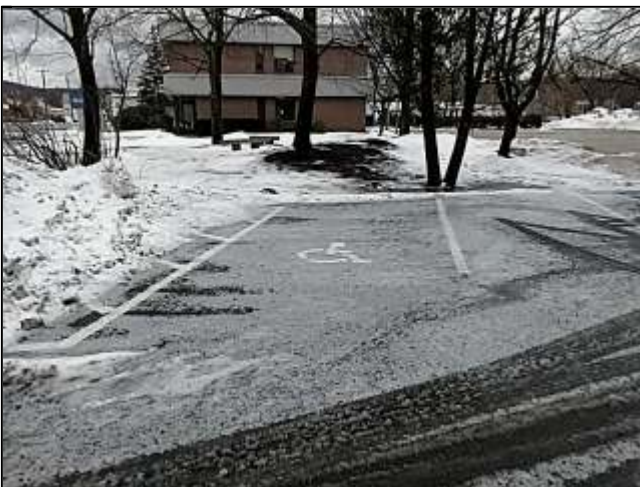
1.3 Overall the asphalt parking area was found to be in good condition. Parking spaces are clearly marked, however there is no designated signage for the handicap spaces.

1.3 Item 3(Picture) No sign for handicap space.

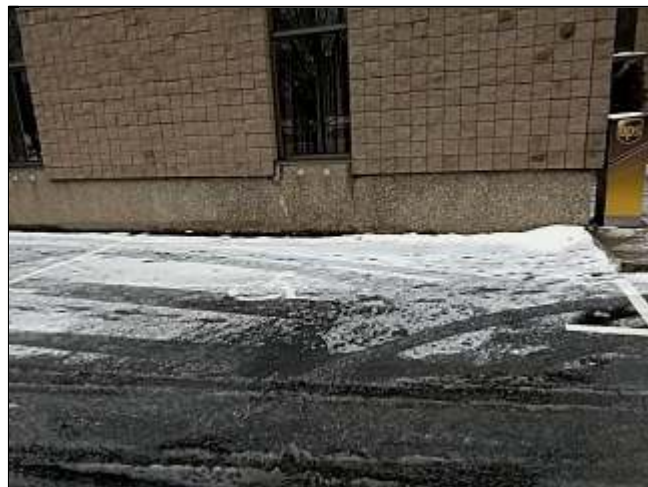
1.3 Item 4(Picture) No signage for designated handicap parking.

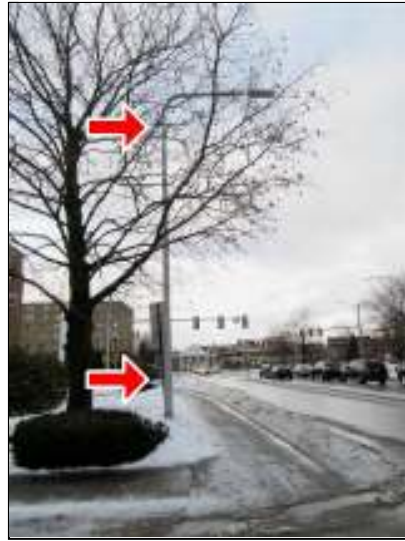
1.4 Item 4(Picture) Municipal overhead lamp at entrance.

Note: The overhead lamp in the parking area may have a missing globe or lamp and may not be functioning. We recommend further evaluation to ensure this overhead lamp is functioning.

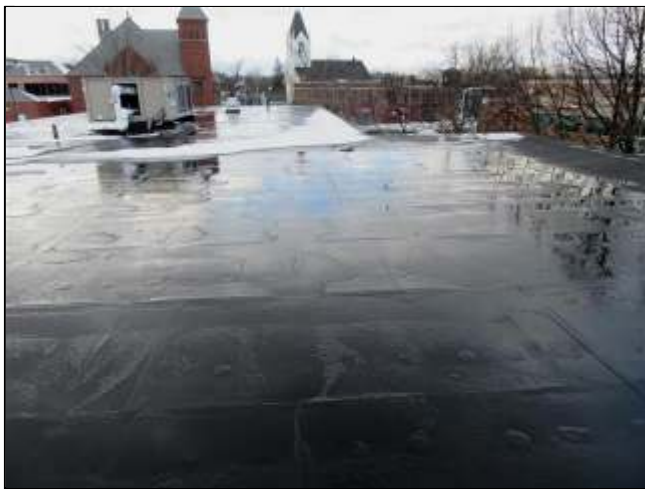
**3.0** Overall the rubber membrane was found to be in poor condition and needs replacement. Most of the fasteners are pushing up against the membrane and there are several voids at the seams (missing underlayment). The rubber membrane under the chiller is in poor condition and appears to be wrinkled due to excessive heat.

The roof is currently leaking as buckets were observed above the suspended ceiling along the rear/middle of the building. There are two center drains located in this area that appear to be leaking, as a result, water is travelling down the center of the building between the roof underlayment and metal roof decking. The underlayment has absorbed water and is now heaving/pushing up against the rubber membrane. This is located at the rear of the chiller towards the south end or rear of the building. The roof replacement and associated components are considered a significant investment.

3.0 Item 1(Picture) View of roof.

We recommend the roof covering, underlayment and drains be replaced by a qualified roofing contractor.

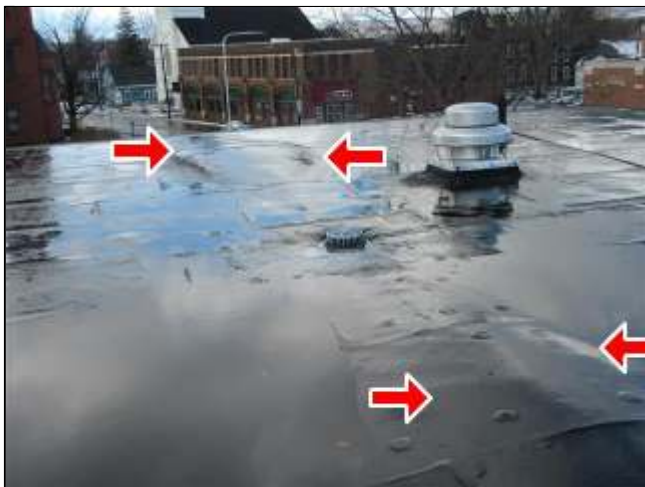
3.0 Item 3(Picture) Underlayment heaving.

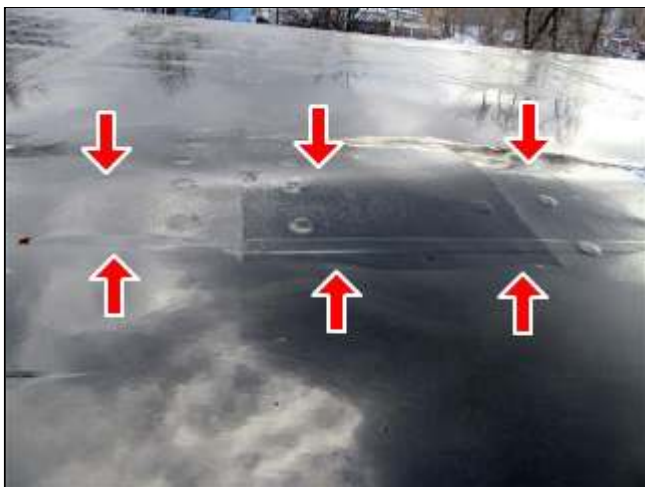
3.0 Item 5(Picture) Underlayment heaving.

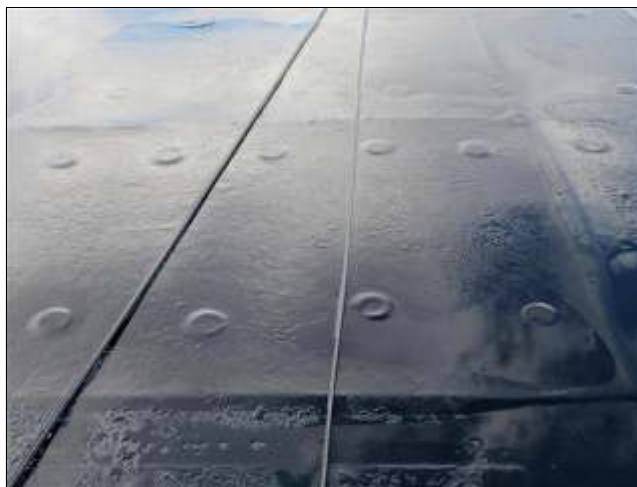
3.0 Item 6(Picture) Fasteners pressing against membrane.

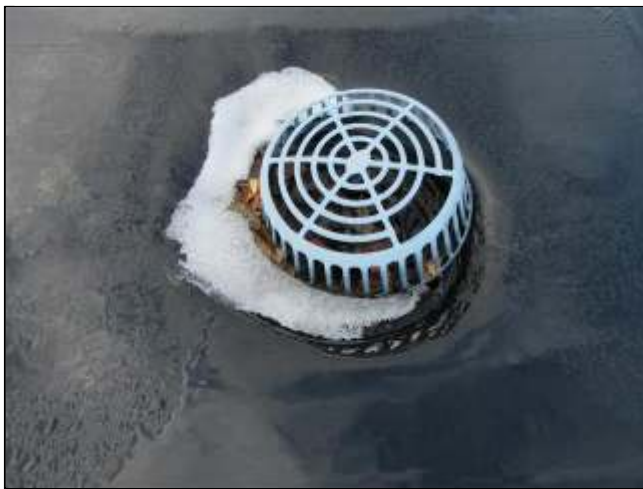
3.3 There are four roof drains which were mostly full of debris and the screens were loose. Although a considerable amount of debris was in each drain they do not appear to be clogged and were draining appropriately at the time of inspection. New drains should be incorporated in the roof replacement.

3.3 Item 1(Picture) Roof drain/typical.

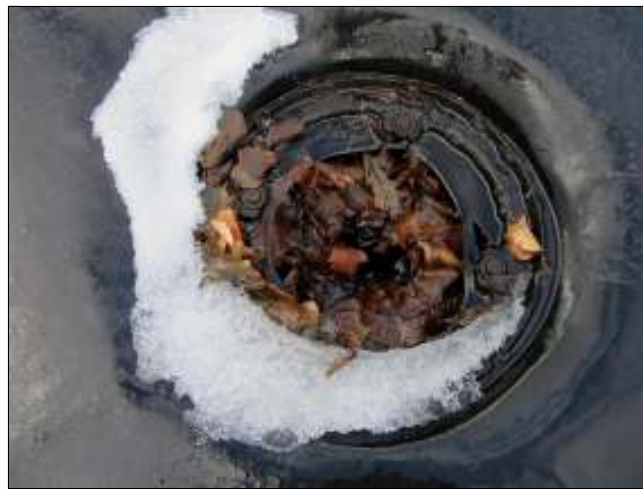
3.3 Item 2(Picture) Loose screen/debris.

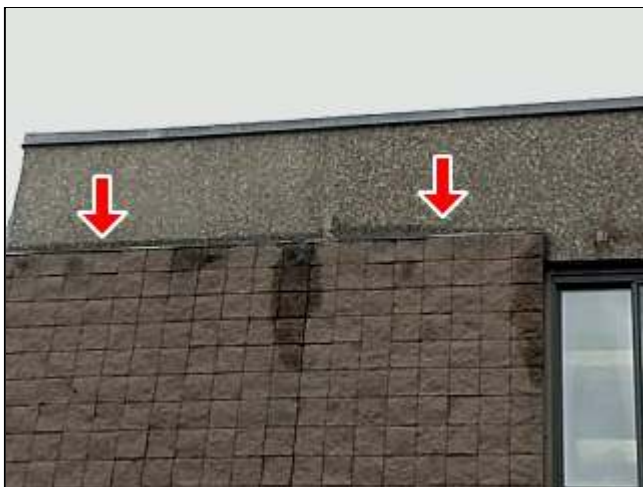
4.0 Several repairs to the precast concrete panels above the split block veneer were observed at all sides of the building. This appears to be caused by failure of the drip cap, poor installation of the drip cap (locating drip cap joints under lighting and near corners) as well as a design flaw in the building.

4.0 Item 1(Picture) Sealed joint.

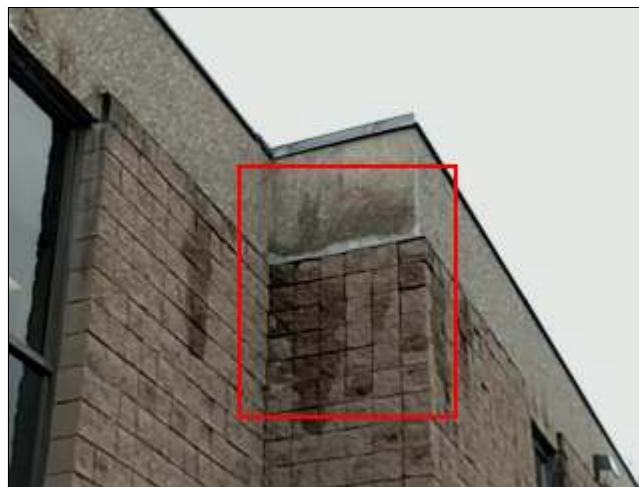
4.0 Item 2(Picture) Previous repairs.

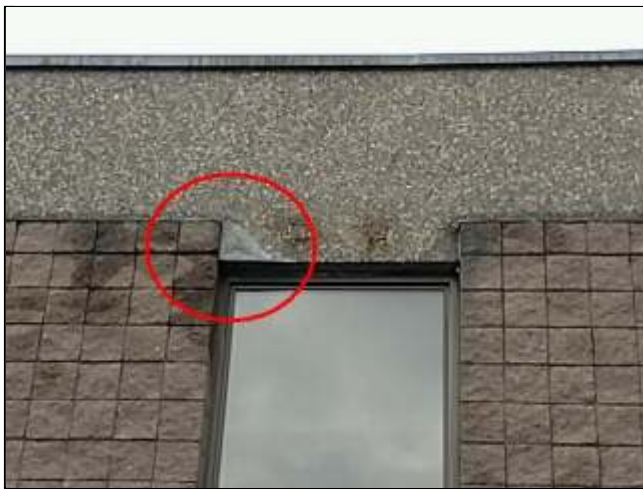
4.0 Item 3(Picture) Previous repair.

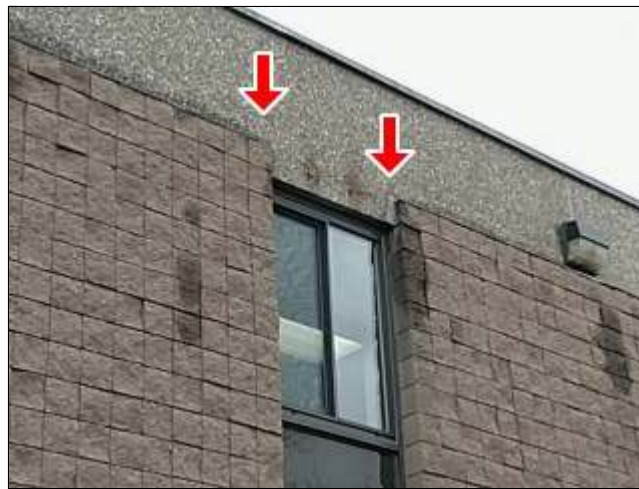
4.0 Item 4(Picture) Poor flashing detail.

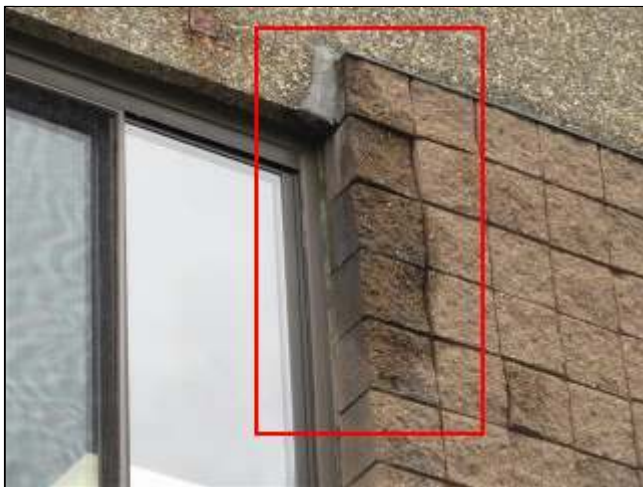
4.0 Item 5(Picture) Previous repairs.

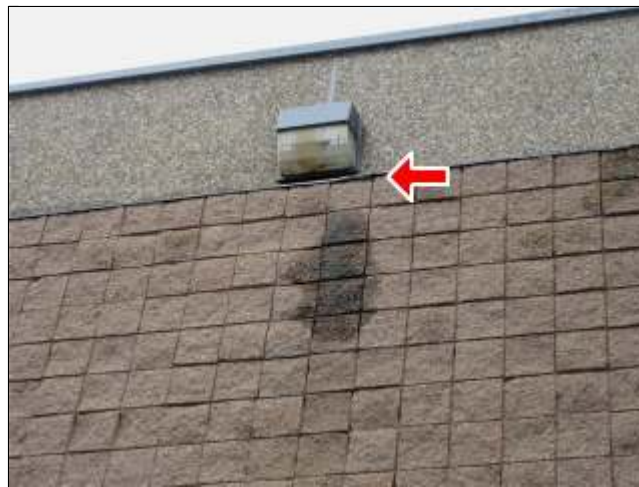
4.0 Item 6(Picture) Seam in flashing under light.

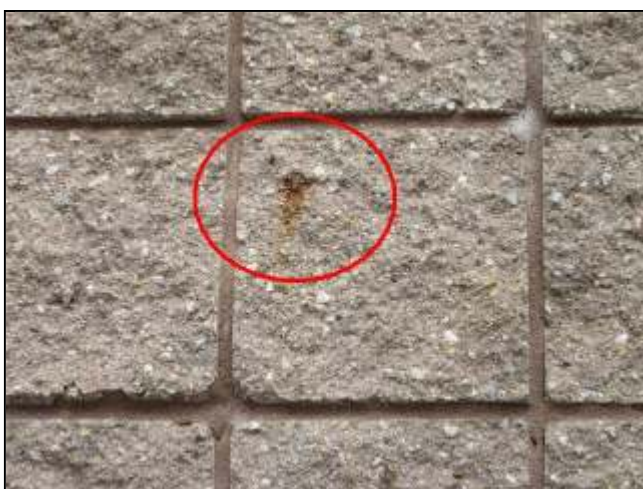
The concrete panels, above the veneer, are recessed which allows snow, ice and rain to accumulate and subsequently runs down the side of the veneer or in some areas, behind. Although no significant leaks were observed inside there is most likely some moisture intrusion between the veneer and masonry block walls. We recommend further evaluation and correction by a qualified contractor. The repair or replacement of the pre-cast concrete panels and veneer is considered a significant investment.

4.0 Item 7(Picture) Evidence of moisture behind veneer.

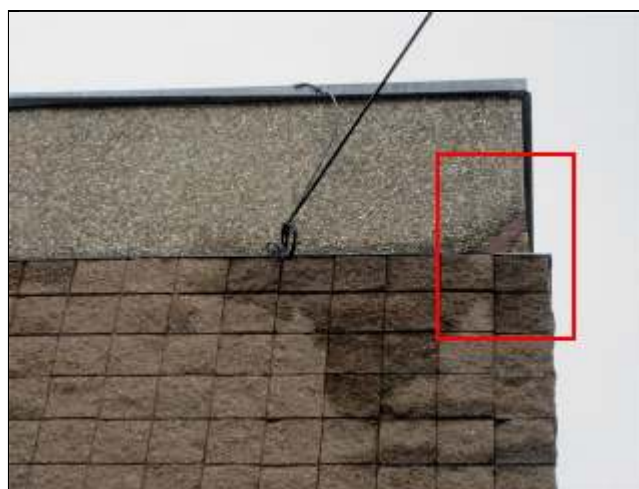
4.0 Item 8(Picture) Previous repair.

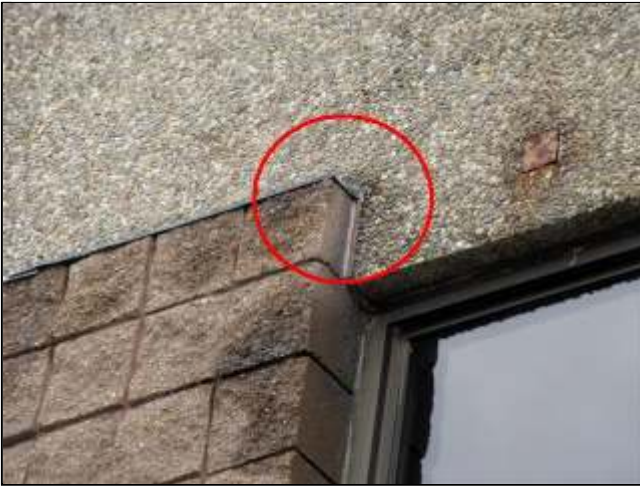
4.0 Item 9(Picture) Poor flashing detail.

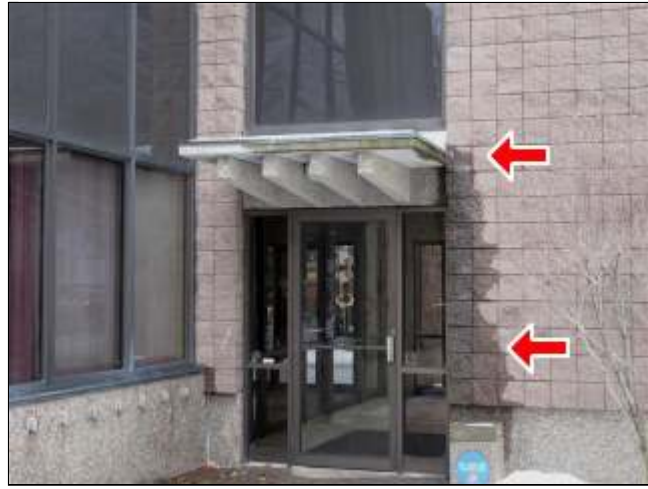
4.0 Item 10(Picture) Poor flashing detail.

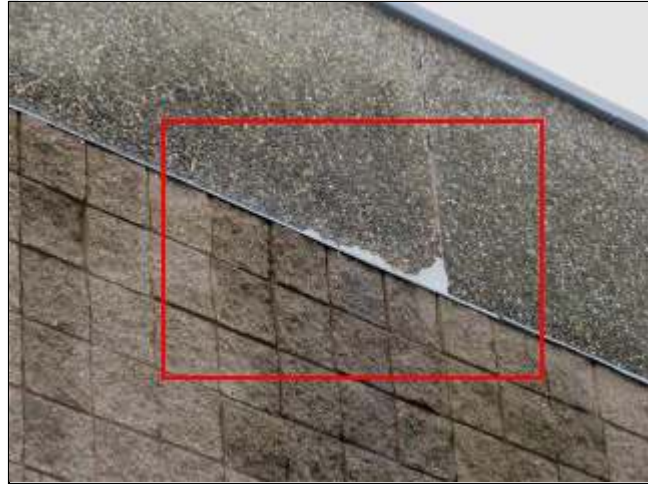
4.0 Item 12(Picture) Previous repair.

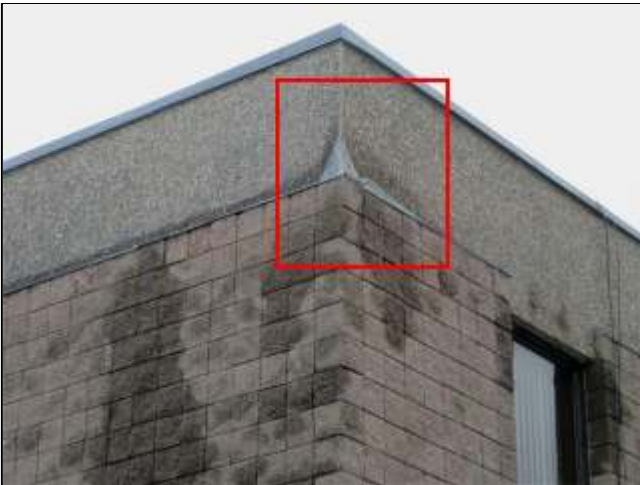
4.0 Item 13(Picture) Previous repair.

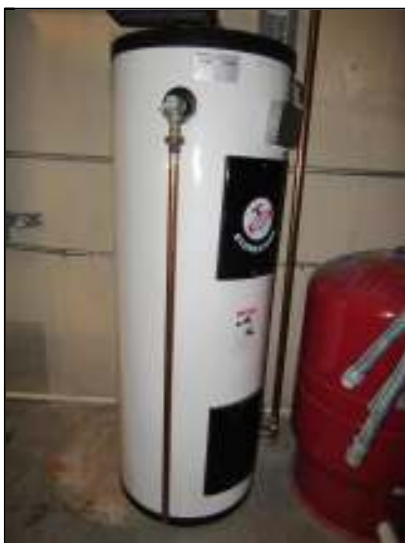
6.2 According to the manufacture's serial number the water heater was produced in 2012, however information recorded on the cabinet suggests it was installed in 2014. We found the water heater to be functioning as intended and supplied sufficient hot water to each of the fixtures in the building.

6.2 Item 1(Picture) MFG 2012/installed 2014.

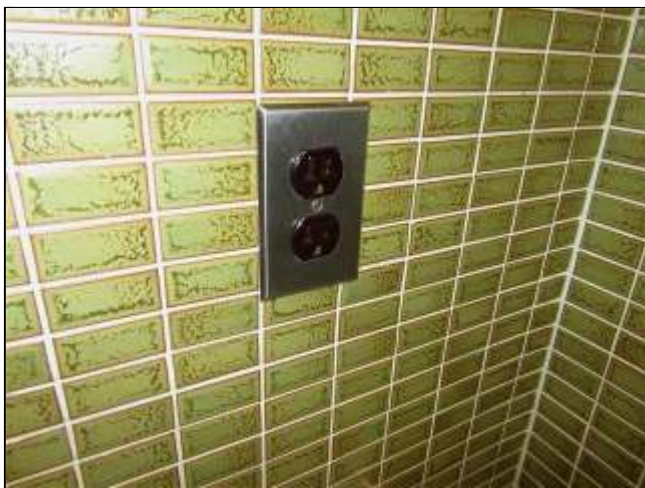
7.4 None of the outlets located in the restrooms are Ground Fault Circuit Interrupter protected (GFCI). GFCI outlets offer protection from electrical shock in the event water comes in contact with the circuit. We recommend all these outlets be replaced by a licensed electrician. This is considered a minor but important safety issue.

7.4 Item 1(Picture) Not GFCI protected.

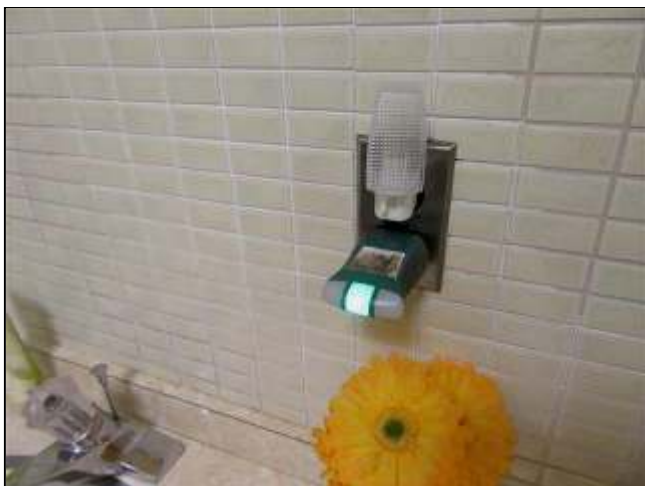
7.4 Item 3(Picture) Not GFCI protected.

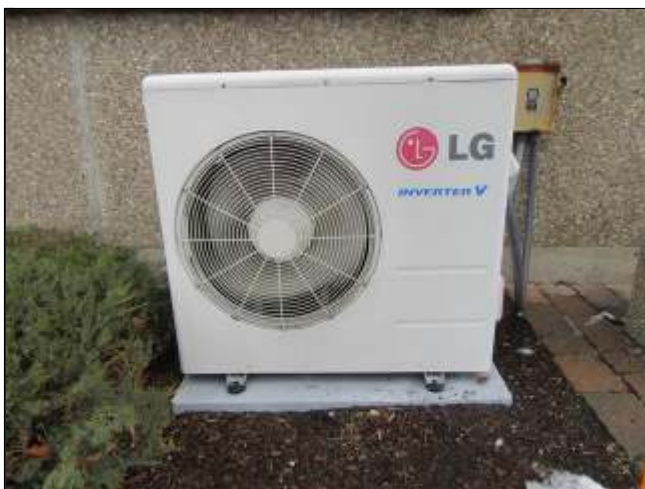
Secondary cooling for the IT room is provided through a mini split unit located at the rear of the building. According to the manufacture's serial number this unit was produced in 2000, therefore is nearing the end of it's average life expectancy. Although functioning as intended we recommend you plan for replacement.

8.5 Item 3(Picture) Mini split for IT room/MFG 2000.
