Russell Inspection Services LLC

Property Condition Assessment

123 Main ST
Anytown NH 01234

Date: 1/1/2018	Time: 08:30 AM	Report ID: 12345
Property: 123 Main ST Anytown NH 01234	Customer: Sample Report

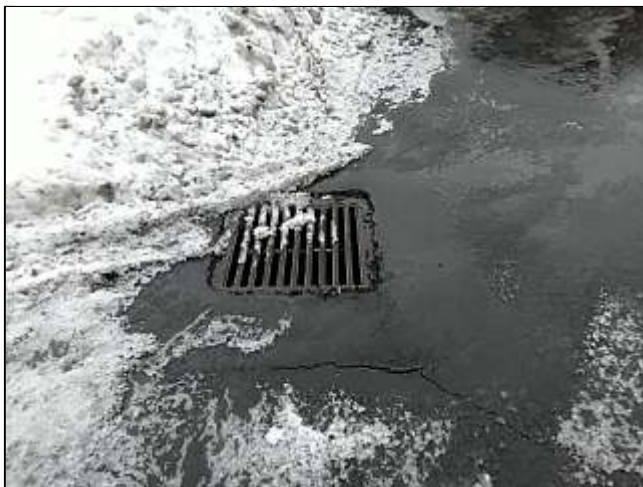
1.1 Item 3(Picture) Rear drain / functioning as intended.

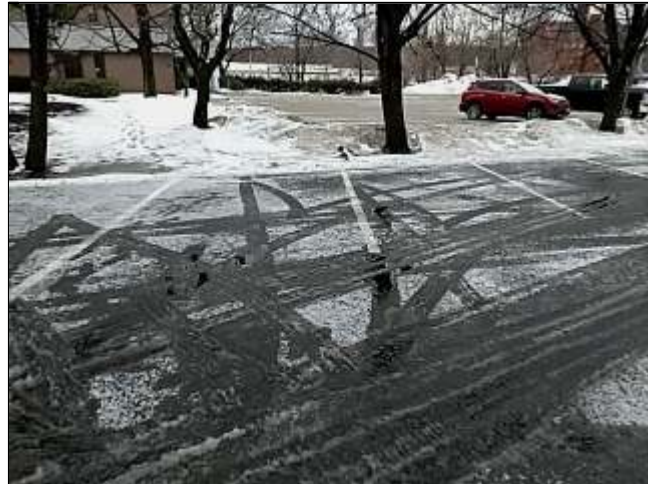
1.3 Overall the asphalt parking area was found to be in good condition. Parking spaces are clearly marked, however there is no designated signage for the handicap spaces.

1.3 Item 2(Picture) Asphalt parking lot in good condition.

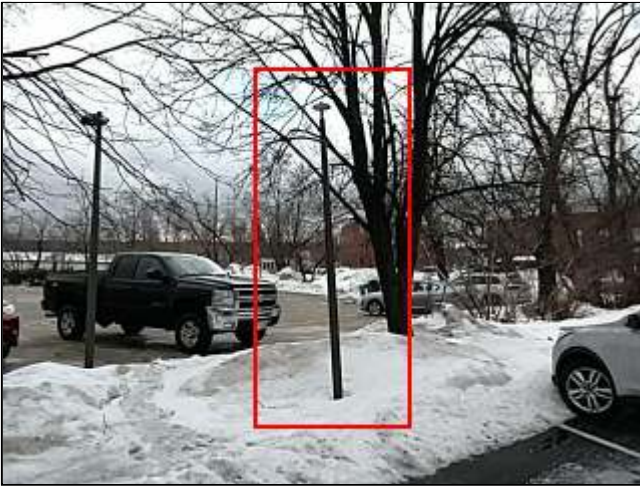
Note: The overhead lamp in the parking area may have a missing globe or lamp and may not be functioning. We recommend further evaluation to ensure this overhead lamp is functioning.

1.4 Item 3(Picture) Overhead lamp and parking lot.

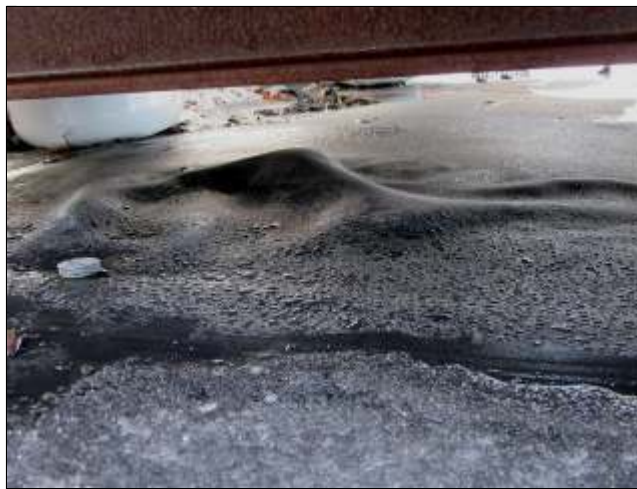
**3.0** Overall the rubber membrane was found to be in poor condition and needs replacement. Most of the fasteners are pushing up against the membrane and there are several voids at the seams (missing underlayment). The rubber membrane under the chiller is in poor condition and appears to be wrinkled due to excessive heat.

3.0 Item 2(Picture) Membrane under chiller.

We recommend the roof covering, underlayment and drains be replaced by a qualified roofing contractor.

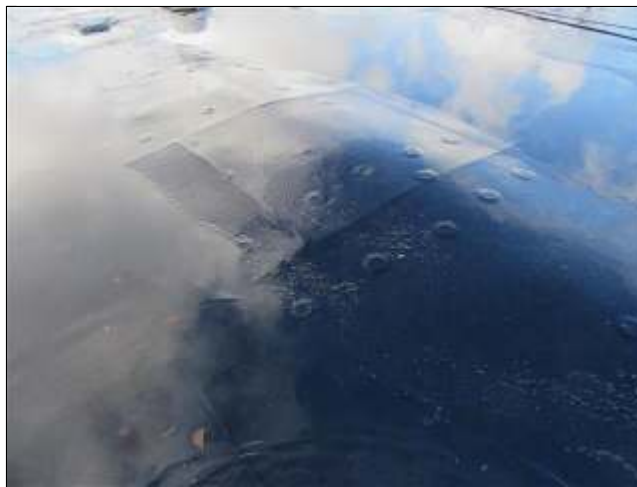
3.0 Item 4(Picture) Underlayment heaving.

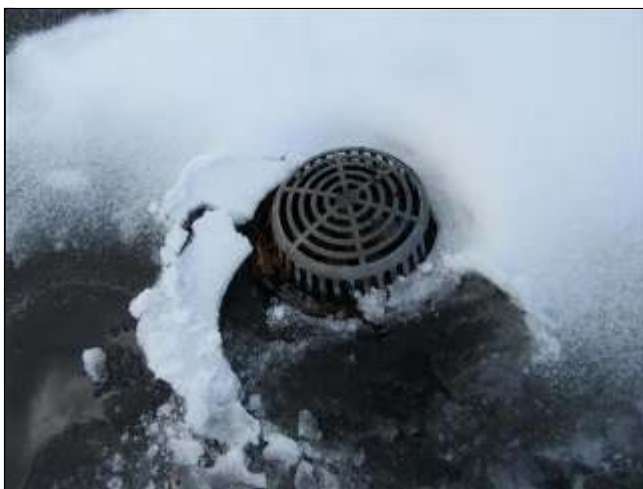
3.3 There are four roof drains which were mostly full of debris and the screens were loose. Although a considerable amount of debris was in each drain they do not appear to be clogged and were draining appropriately at the time of inspection. New drains should be incorporated in the roof replacement.

3.3 Item 3(Picture) Typical drain.

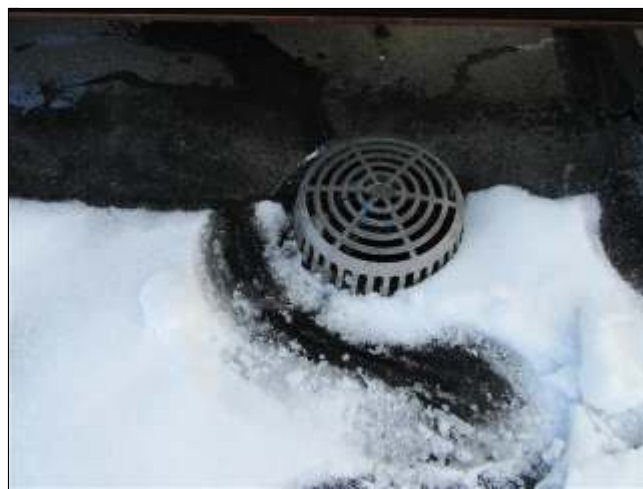
3.3 Item 4(Picture) Typical drain.

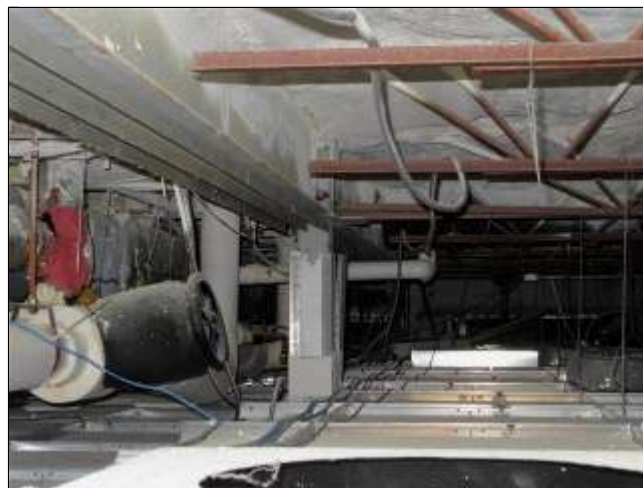
3.4 The roof structure consists of open web steel joists supported by steel beams with metal roof decking. The visible areas were found to be in good condition.

3.4 Item 2(Picture) Roof structure in good condition.

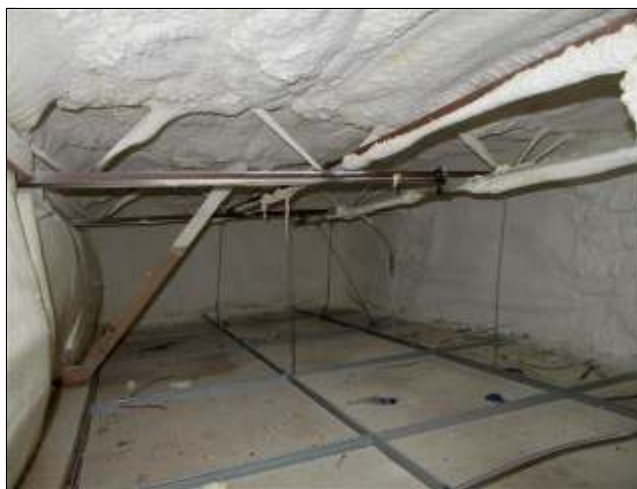
3.5 The roof structure has been insulated with closed cell spray foam which was found to be in good condition.

3.5 Item 4(Picture) Spray foam in good condition.

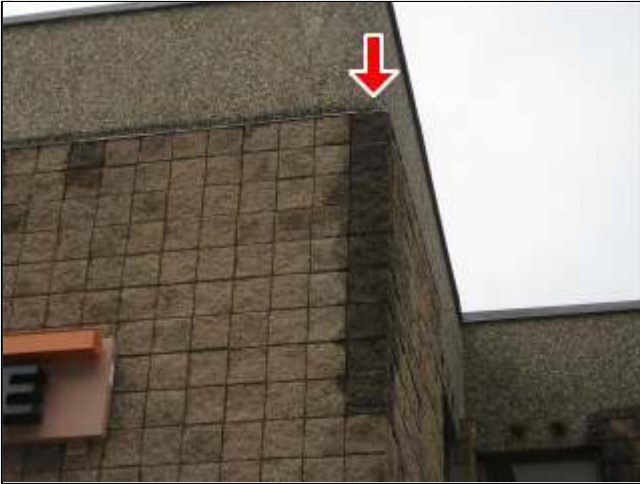
4.0 Several repairs to the precast concrete panels above the split block veneer were observed at all sides of the building. This appears to be caused by failure of the drip cap, poor installation of the drip cap (locating drip cap joints under lighting and near corners) as well as a design flaw in the building.

4.0 Item 11(Picture) Flashing joint at corner.

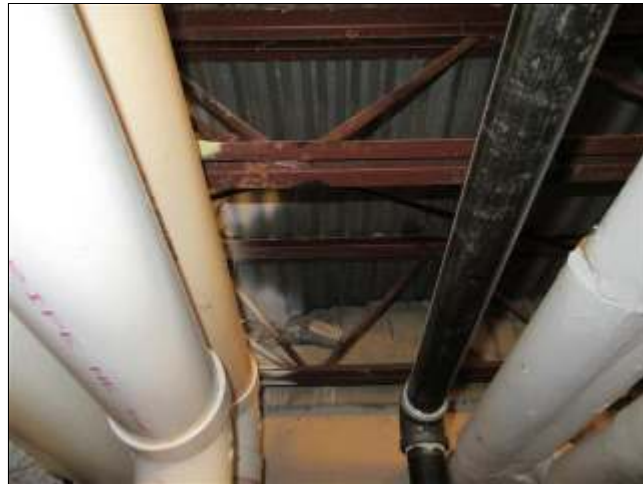
5.2 The floor structure consists of open web steel trusses supported by steel I-beams and steel columns. The majority of the floor structure was covered with suspended ceiling tiles therefore not all areas were evaluated. Several ceiling tiles throughout the building were removed and the floor structure was found to be in good condition in these areas.

5.2 Item 2(Picture) Open web joists in good condition.

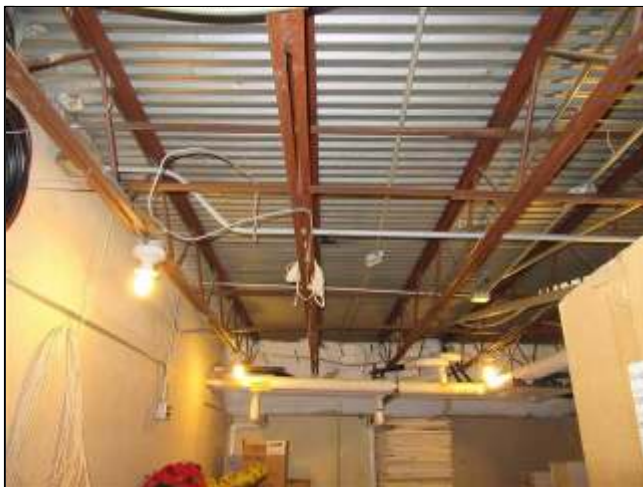
5.2 Item 3(Picture) Floor structure/good condition.

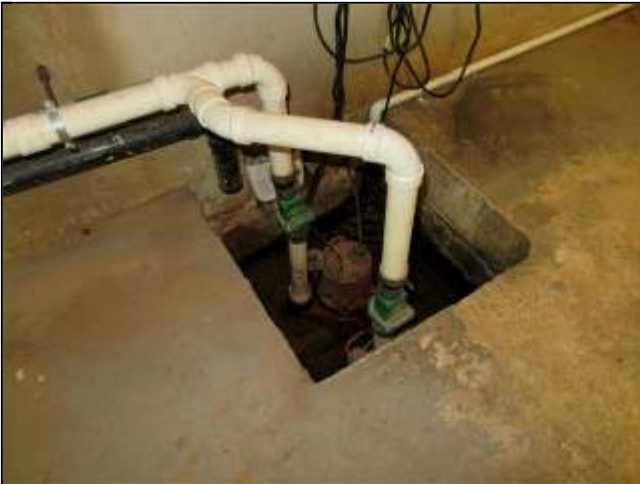
6.4 The sump pump was functioning as intended and appears to drain into a sewer line connected to the municipal storm water drains located at the south side (rear) of the building..

6.4 Item 1(Picture) Sump pump.

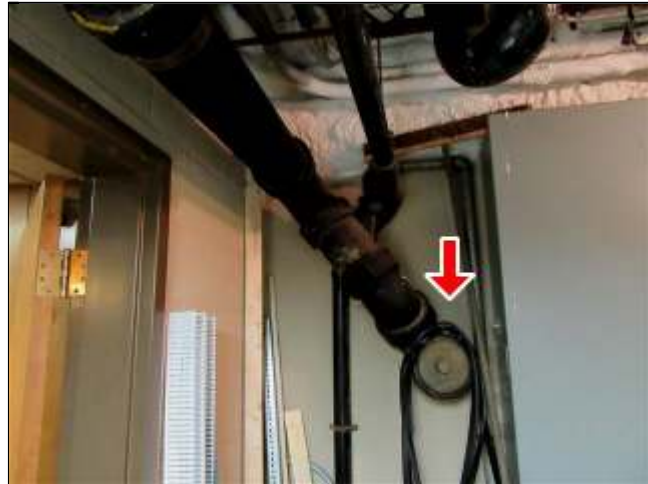
6.4 Item 2(Picture) Storm water drain.

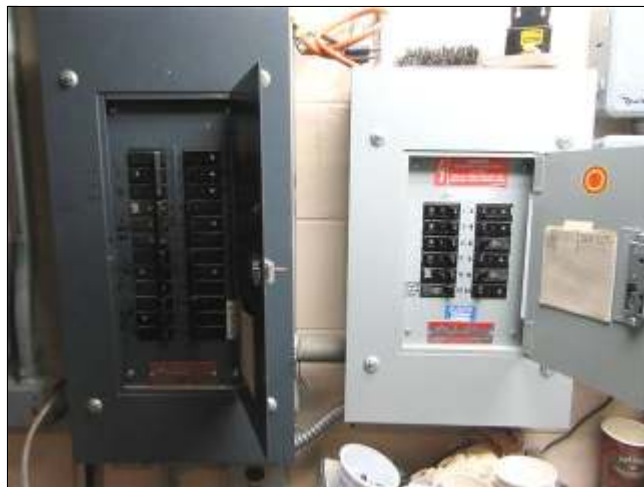
7.1 Item 2(Picture) Basement service panels.

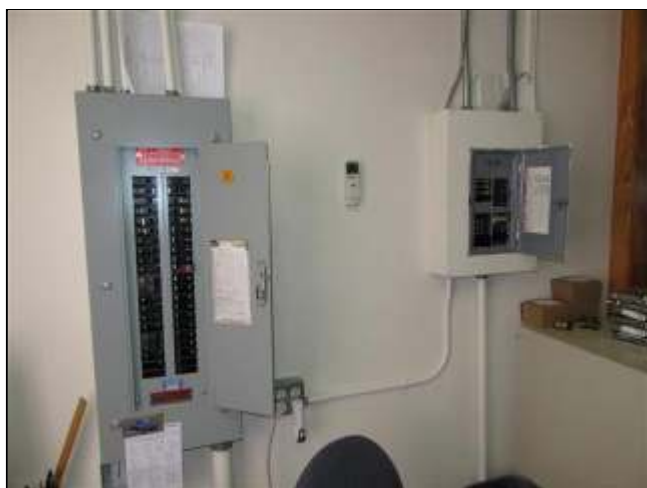
7.1 Item 3(Picture) 1ST floor panels.

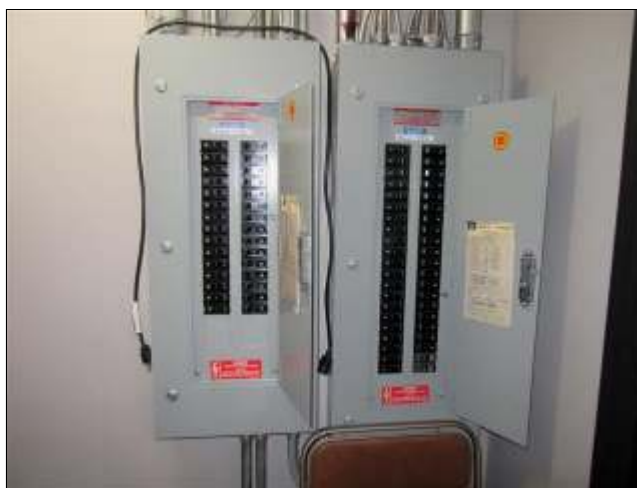
7.1 Item 4(Picture) 2ND floor panels.

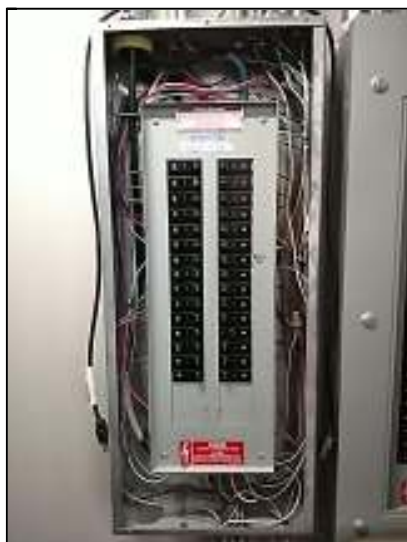
7.1 Item 5(Picture) View inside 200 AMP/2ND floor.

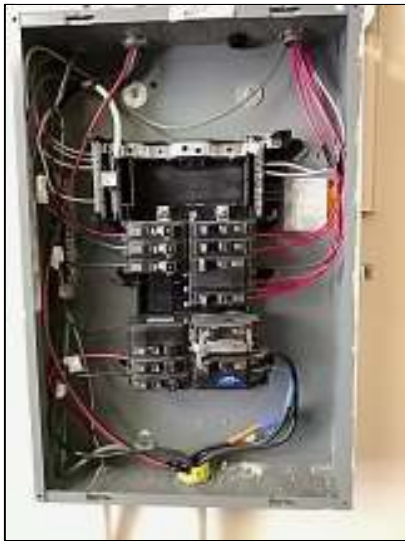
7.1 Item 6(Picture) View inside 60 AMP/1ST floor.

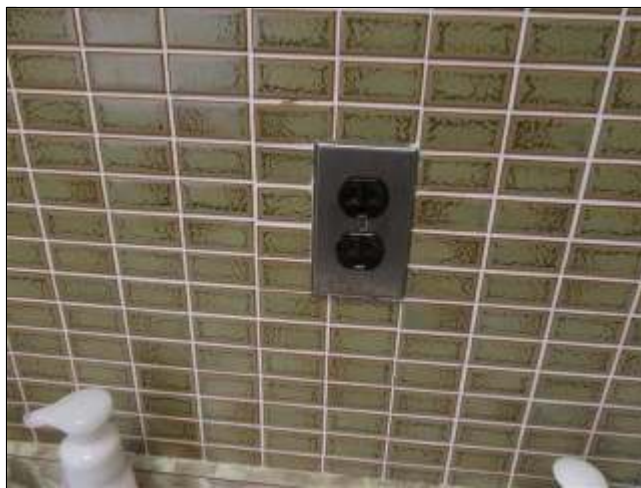
7.4 None of the outlets located in the restrooms are Ground Fault Circuit Interrupter protected (GFCI). GFCI outlets offer protection from electrical shock in the event water comes in contact with the circuit. We recommend all these outlets be replaced by a licensed electrician. This is considered a minor but important safety issue.

7.4 Item 2(Picture) Not GFCI protected/Typical.

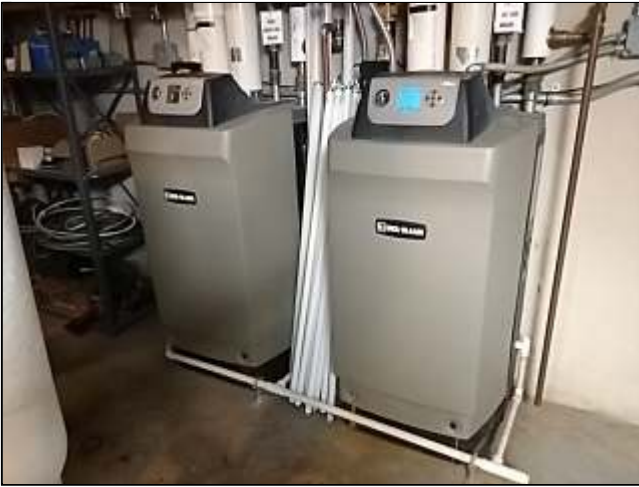
8.0 The primary heating system consists of two boilers located in the basement utility room that circulate hot water through radiators located throughout the building. Secondary heat is supplied through two hydronic air handlers and insulated duct work. According to the manufacture's serial numbers the boilers were produced in 2009. The air handlers appear to be original to the building, however were found to be in above average condition and functioning as intended.

8.0 Item 1(Picture) 1st and 2nd floor primary boilers.

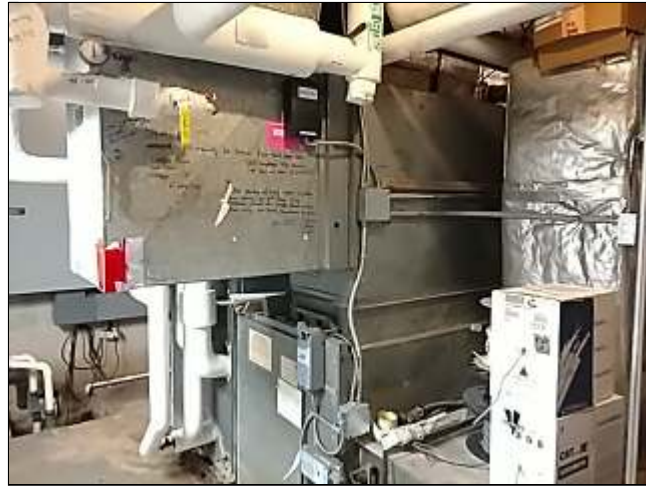
8.0 Item 2(Picture) Air Handlers / secondary

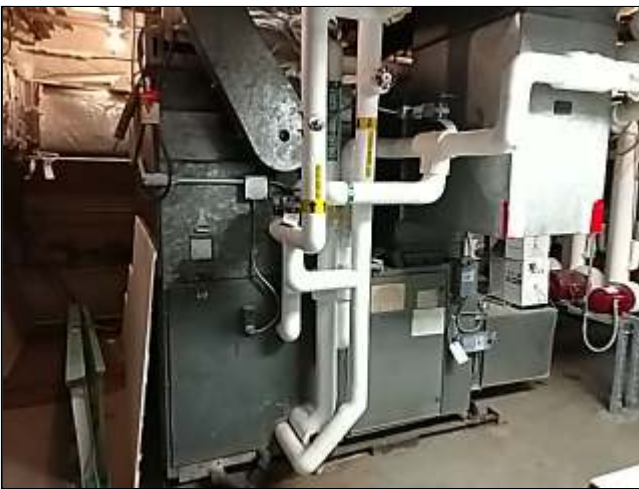
8.0 Item 3(Picture) Air Handlers in good condition.

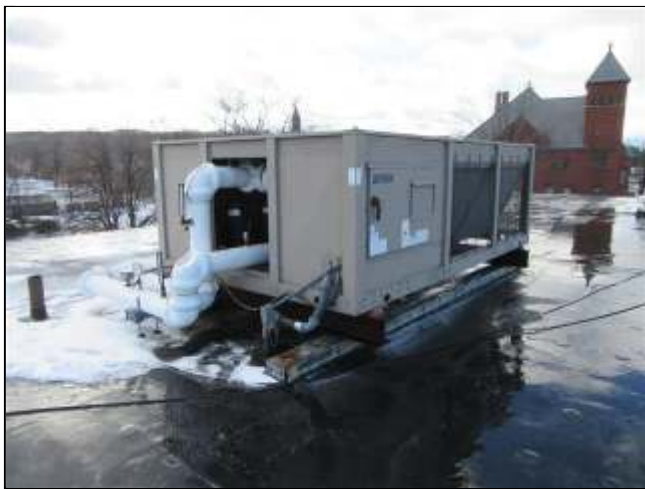
8.5 Primary cooling for the building consists of a chiller located on the roof. According to the manufacture's serial tag this chiller was produced in 2009. Due to ambient temperature's below 40 degrees we did not operate the air conditioning systems.

8.5 Item 1(Picture) Chiller on roof.

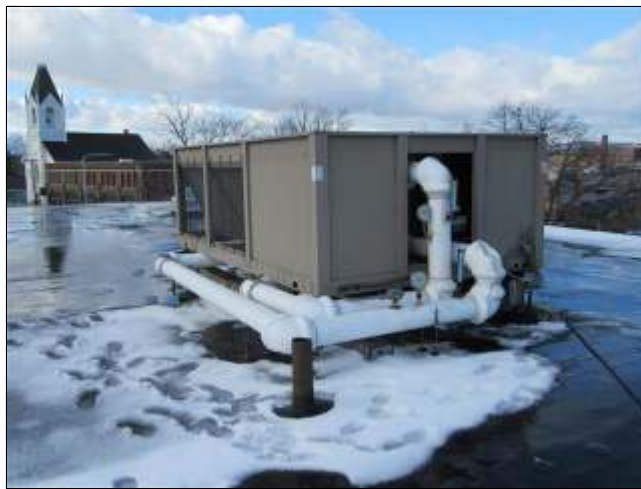
8.5 Item 2(Picture) Chiller/MFG 2009.

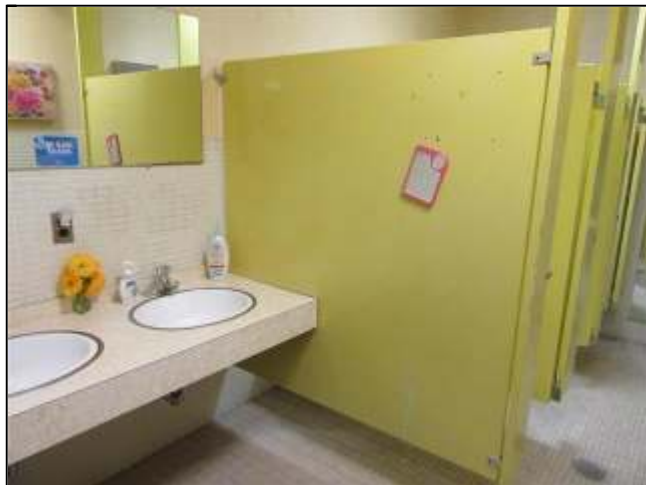
There is one men's and ladies restroom located on each floor. Each restroom was found to be in fair but functioning condition with dated fixtures, wall and floor coverings. Some upgrades should be planned.

Ladies restroom/2ND floor

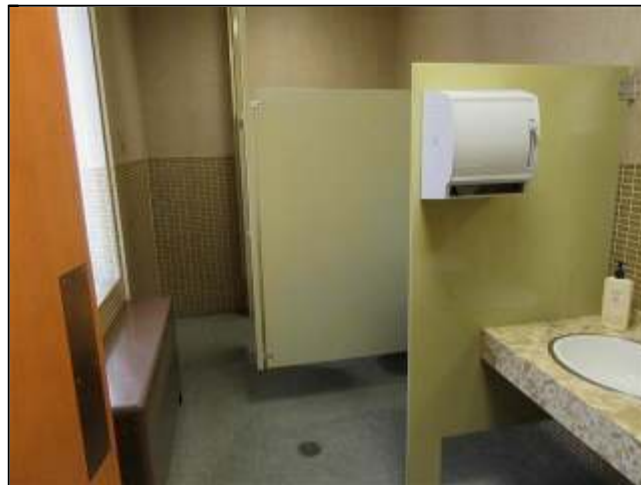
Men's restroom/2ND floor.
