Russell Inspection Services LLC

Property Condition Assessment

123 Main ST
Anytown NH 01234

Date: 1/1/2018	Time: 08:30 AM	Report ID: 12345
Property: 123 Main ST Anytown NH 01234	Customer: Sample Report

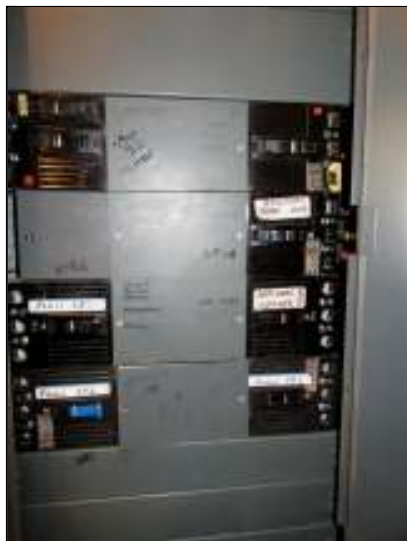
7.1 Item 1(Picture) View of disconnects/basement.

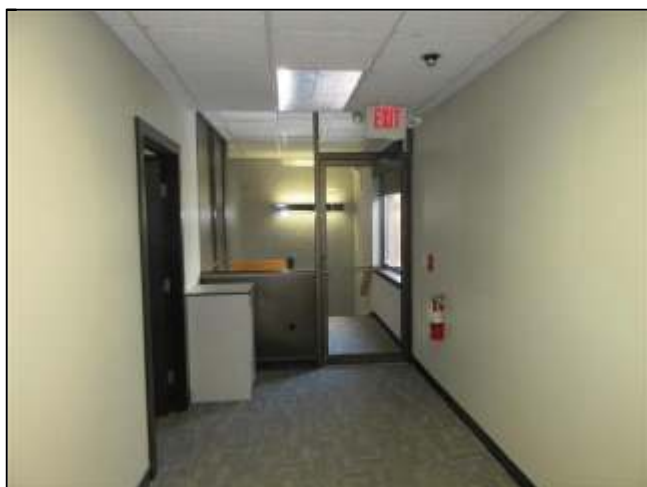
Proper signage in place.

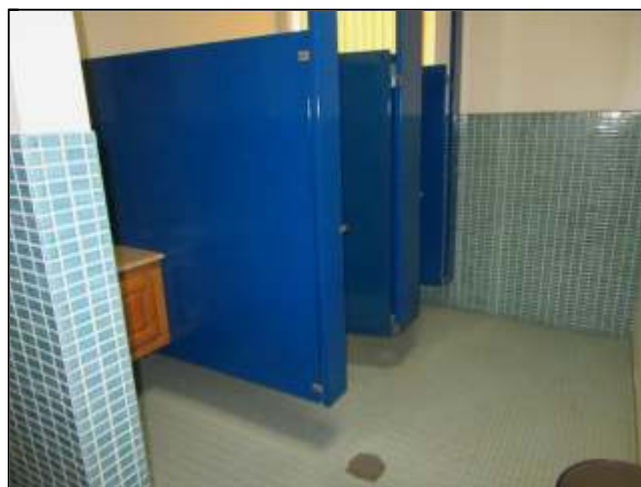
Ladies restroom/1ST floor.
